NRL Report 6698

**Subcritical Flaw Growth in 9Ni-4Co-0.25C
Steel - A Fatigue and Fractographic
Investigation and Its Relationship to
Plane Strain Fracture Toughness**

T. W. CROOKER, L. A. COOLEY, E. A. LANGE, AND C. N. FREED

**NAVAL RESEARCH LABORATORY
Washington, D.C.**

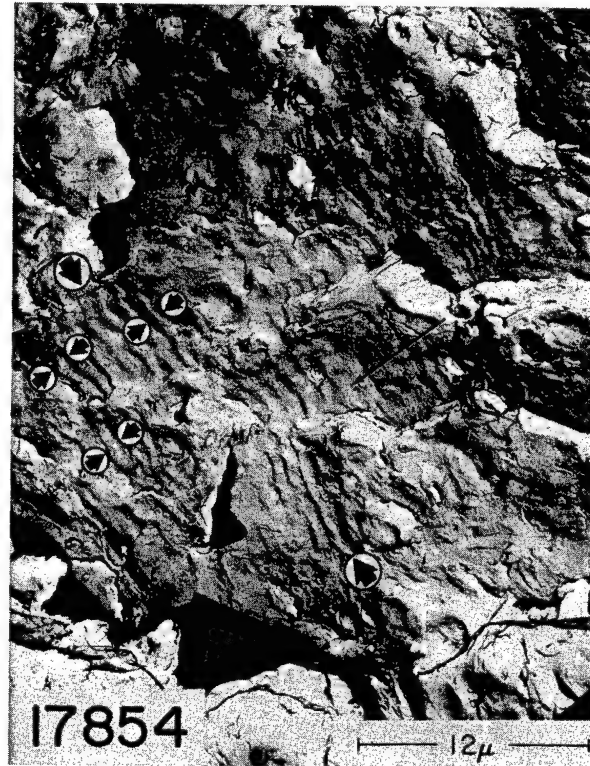
Fig. 9 - Tension-to-tension fatigue markings in a specimen loaded from 250 to 1750 lb. A packet of striations is shown between the large arrows while individual striations appear between the small arrows.

The first region studied encompasses the first 0.1 in. of crack growth, where $a = 0.50$ in. and $\Delta K = 36$ ksi $\sqrt{\text{in}}$. Figures 9 and 10 are from the specimen loaded 250 to 1750 lb. The ruptured surface consists of broad, shallow striations (between the small arrows in

Fig. 9) or tongues and ridges as seen in Fig. 10. The broad, shallow striations comprised 40 to 60 percent of the surface examined. At higher magnifications (Fig. 11) fatigue striations in the specimen loaded 500 to 2000 lb are broad and shallow with the edges of the individual striations outlined by discontinuous tongues. A further illustration of the surface complexity in this region is shown in Fig. 12. Shallow striations appear in the upper left, with shallow, equiaxed dimples in the lower left portions of the fractograph.

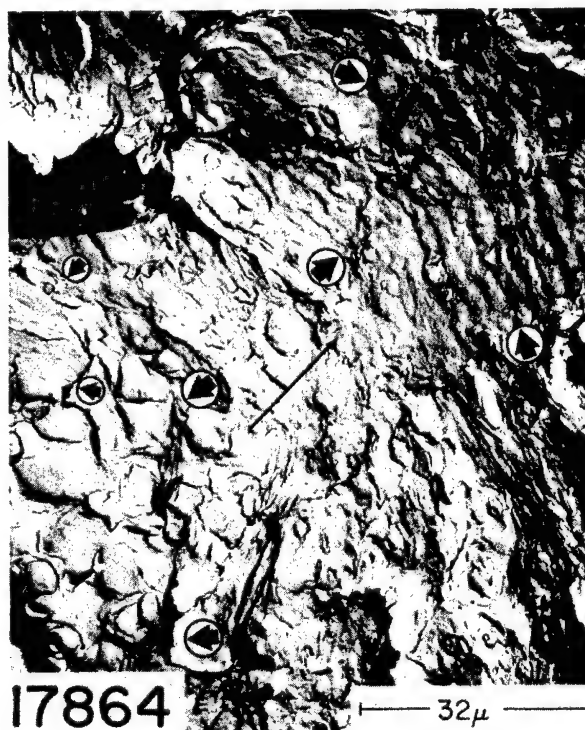
Fig. 12 - Tension-to-tension fatigue markings in a specimen loaded from 250 to 1750 lb. The surface consists of broad, shallow striations (upper right), shallow equiaxed dimples (lower left), and ridges (left center).

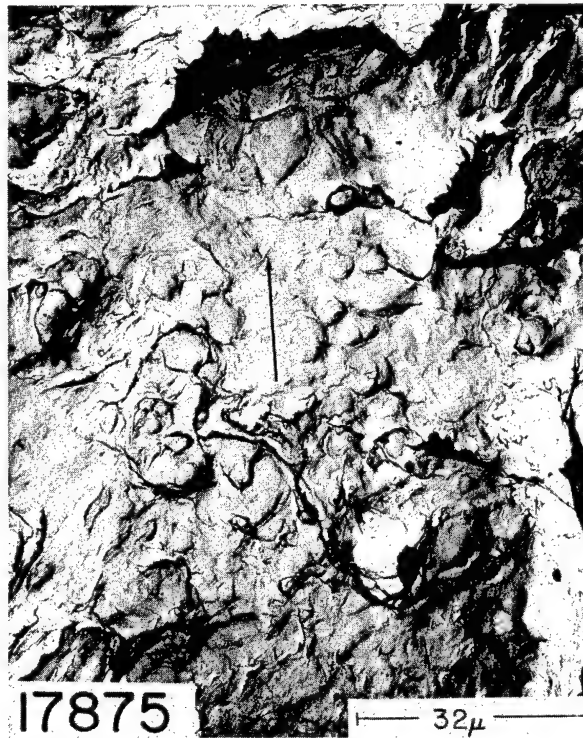
Fig. 13 - Tension-to-tension fatigue markings in a specimen loaded from 250 to 1750 lb. The surface consists of shallow dimples and tear ridges orientated in a random fashion to the fracture path.

As the crack front advances to the second area studied, the broad, shallow striations disappear. For flaw sizes ranging from 0.7 to 0.9 in., the surface of the specimen loaded 250 to 1750 lb consists of shallow dimples and random tear ridges as in Fig. 13 or shallow, equiaxed dimples as in Fig. 14. These features comprised approximately 80 percent of the areas examined.

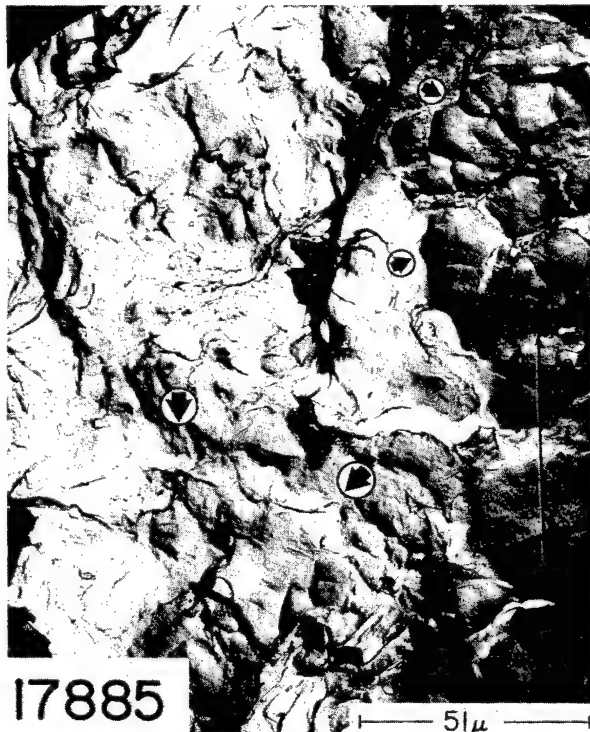
Fig. 14 - Tension-to-tension fatigue markings in a specimen loaded from 250 to 1750 lb. The surface consists of shallow dimples.

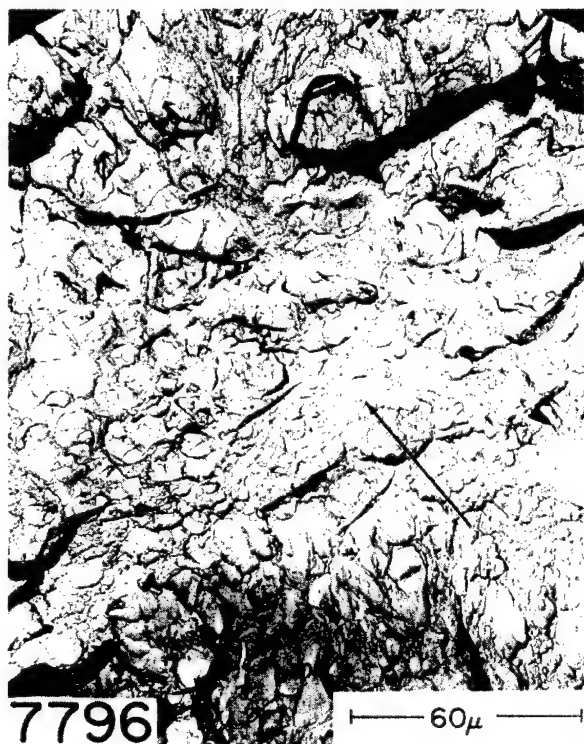
Fig. 16 - Region of fast fracture for a specimen loaded from 500 to 2000 lb. The surface consists of large and small dimples.

The final area studied lies within the region of fast, terminal fracture. The separation consists exclusively of dimpled rupture. Figure 16 illustrates this feature obtained from the specimen loaded 500 to 2000 lb. The microfracture mode is dimpled rupture with no single dimple size predominating.
